This section contains ten case studies which illustrate some of the principles of the acoustic design of schools described in previous sections, and give examples of solutions to problems of poor acoustics in schools.

The school is situated at a considerable distance from the main road running through a large village in a quiet residential area. In the early 1990s, it was extended by adding seven new classbases and a new multi-purpose hall. Activities in the hall include assemblies, singing, concerts and physical education. The hall is of particular interest because it required remedial measures not long after completion to alleviate acoustic problems that were being experienced by teaching staff.

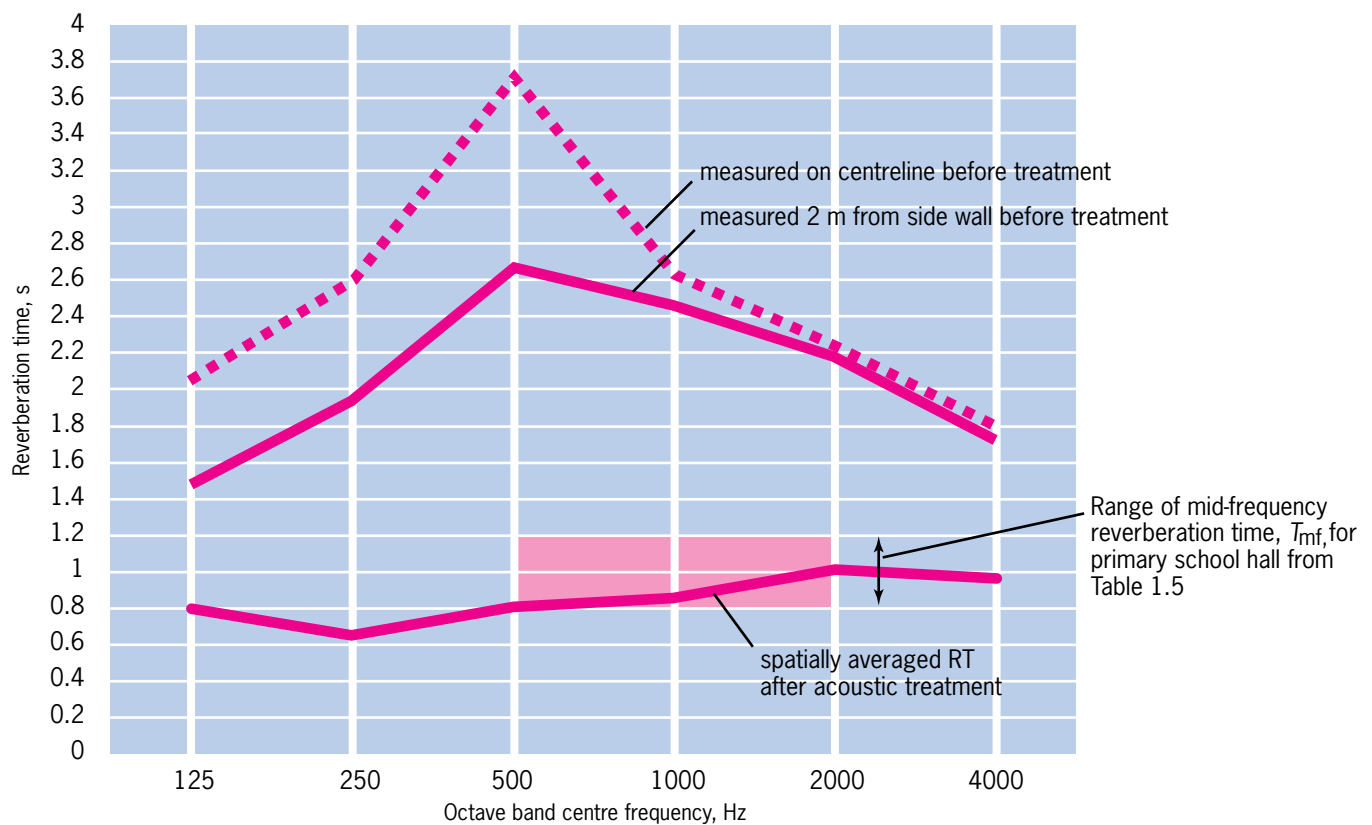
Figure 7.1.5: Measured reverberation time in the new hall before and after implementation of acoustic measures

remedial work. Two sets of measurements were made; one with the source and receiver on the centreline of the hall and the other with the receiver positioned 2 m from a side wall. Measurements were made while the space was unoccupied. Curtains were pulled back to their normal bunched positions either side of internal and external doors and windows. This

arrangement was considered to produce the most reverberant condition likely to be encountered during every day small group activities.

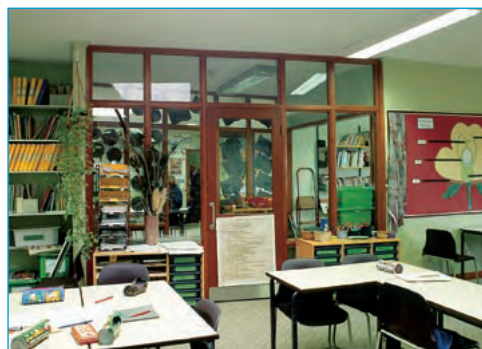
Figure 7.3.2: Arrangement of open-plan teaching spaces following modifications
(a) floor plan
(b) new glazed partition extending the group room

The teachers reported an immediate improvement in aural conditions with the installation of the partitions. They found that they were now only disturbed by the classbase immediately adjacent to them. By strategic location of items of tall furniture they were able to slightly reduce this remaining source of disturbance.

The erection of a physical barrier across the middle of the open-plan teaching area was clearly effective in improving conditions. It is important to note the constructional simplicity of this barrier and its acoustical effectiveness in reducing sound transmission. This was achieved by using two partitions with a large air cavity in between (the extended group room). A single partition would have needed to be substantially heavier with more elaborate acoustical detailing.

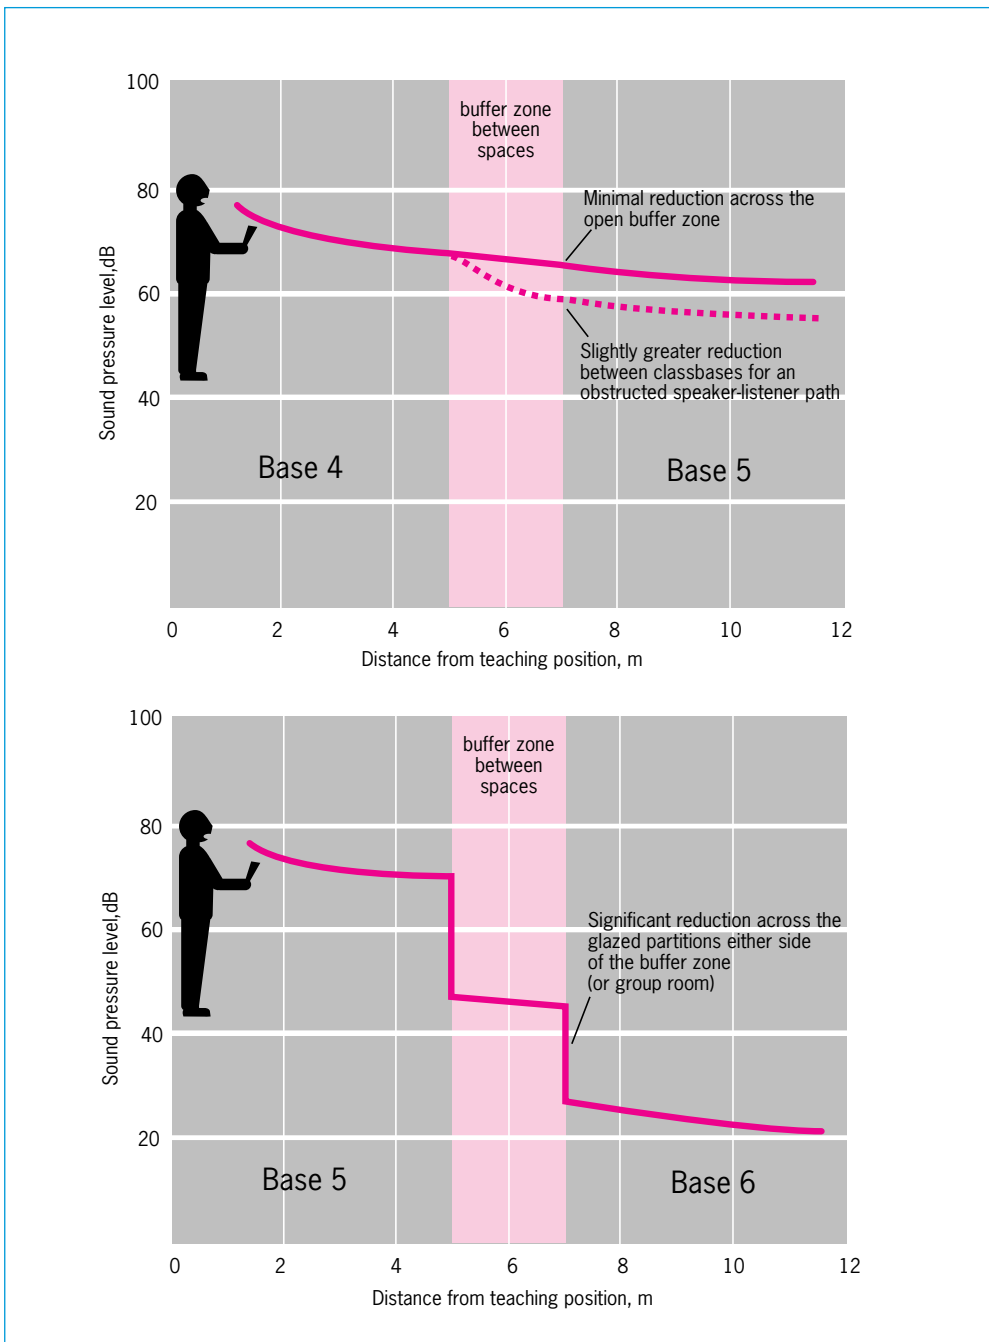
Figure 7.3.4: Sound propagation from one classbase to another (a) without full height partition

By comparing the two figures, it is evident that the reduction in sound level with distance between bases 4 and 5 is very modest compared with the large reduction between bases 5 and 6 (ie across the partition). This is clearly reflected by the subjective impressions of teachers who are disturbed by noise from an adjacent classbase on the same side of the partition but are not disturbed by classbases beyond the partition.

The results for the three paths are shown in Figures 7.3.4 (a) and (b).

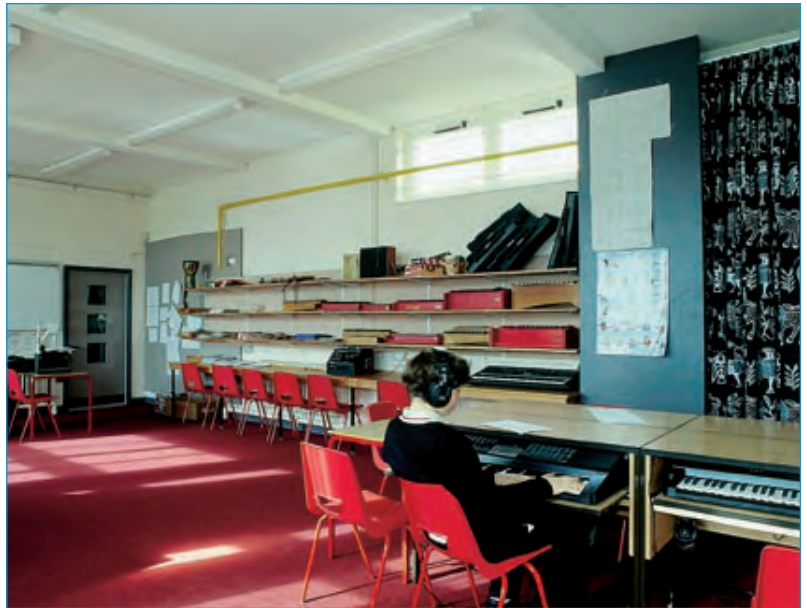
Figure 7.4.1:
(a) Plan of the original workshop
(b) Plan showing conversion to music accommodation

were hard, resulting in an unacceptably long reverberation time of 2 seconds. Standing waves and flutter echoes were likely due to parallel walls and hard surfaces.

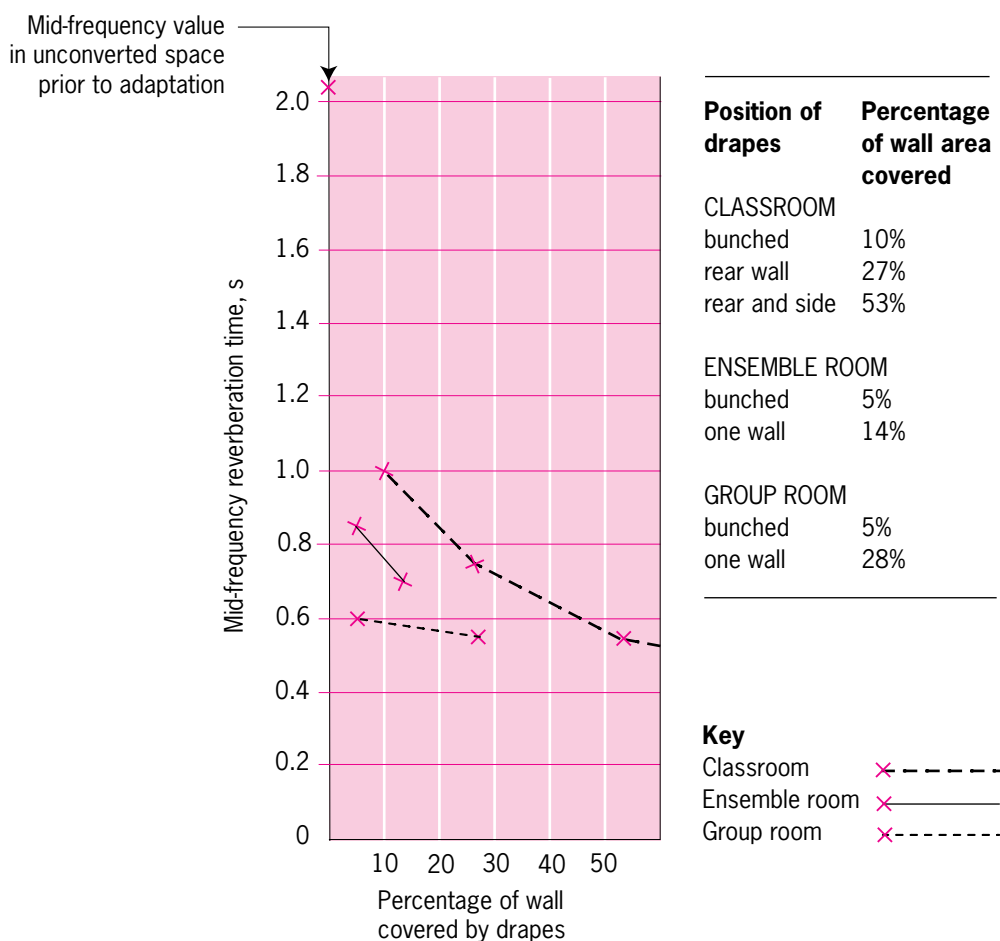
Figure 7.4.3: Graph showing effects of drapes on reverberation times in classroom, ensemble room and group room

that curtains can be very effective in reducing mid-frequency reverberation time. Because of the number of variables combining to affect the reverberation time in a room including volume, the weight and location of curtains, surface finishes and furniture, the results shown here are indicative only. The graph shows that the ensemble room at 13 m² has a measured RT of 0.7 to 0.8 seconds, within the range given in Table 1.5 of 0.6 to 1.2 seconds for an ensemble room.

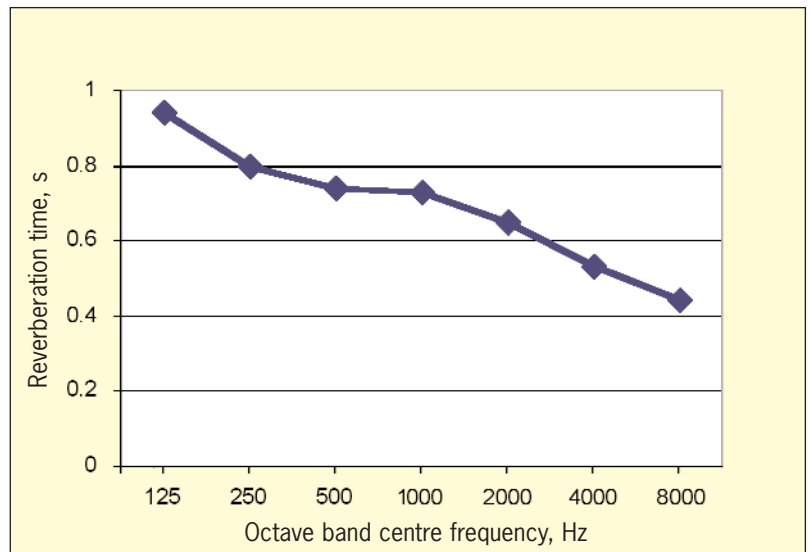
Figure 7.6.7: Reverberation times in unoccupied Class 4

The measured reverberation times (RTs) are shown in Figure 7.6.7. The T_{mf} is above the value specified in Table 1.5. In addition, detailed analysis of the measured impulse responses showed flutter echoes between the parallel, reflective walls. These were not at such a level as to be annoying but they probably reduce speech clarity in the room. The room has predominantly reflective wall surfaces and

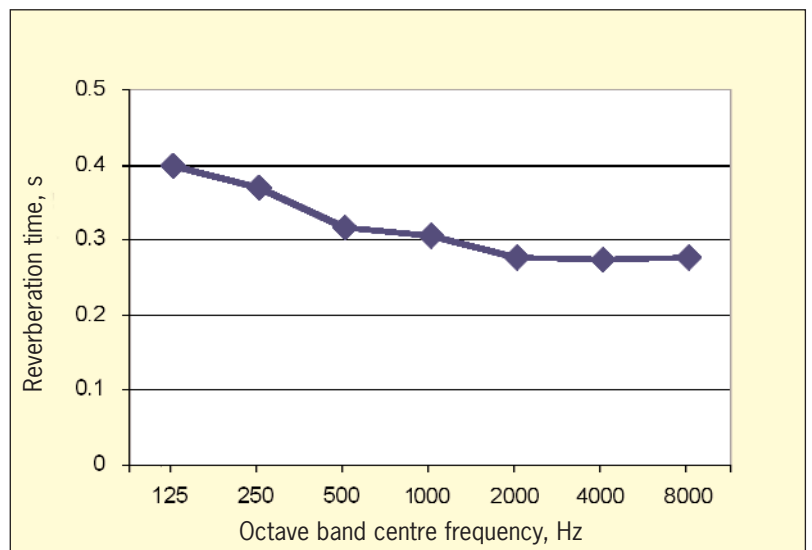
Figure 7.6.8: Reverberation times in unoccupied RPD room

The measured RTs are shown in Figure 7.6.8. As expected for an RPD room, the T_{mf} is lower than the value of 0.4 seconds given in Table 1.5 for classrooms designed specifically for use by hearing impaired pupils. Furthermore, the RT across the frequency range is lower than 0.4 seconds as recommended in Table 6.1. There are no apparent flutter echoes or other problems and no complaints of acoustic problems in this room, which would be

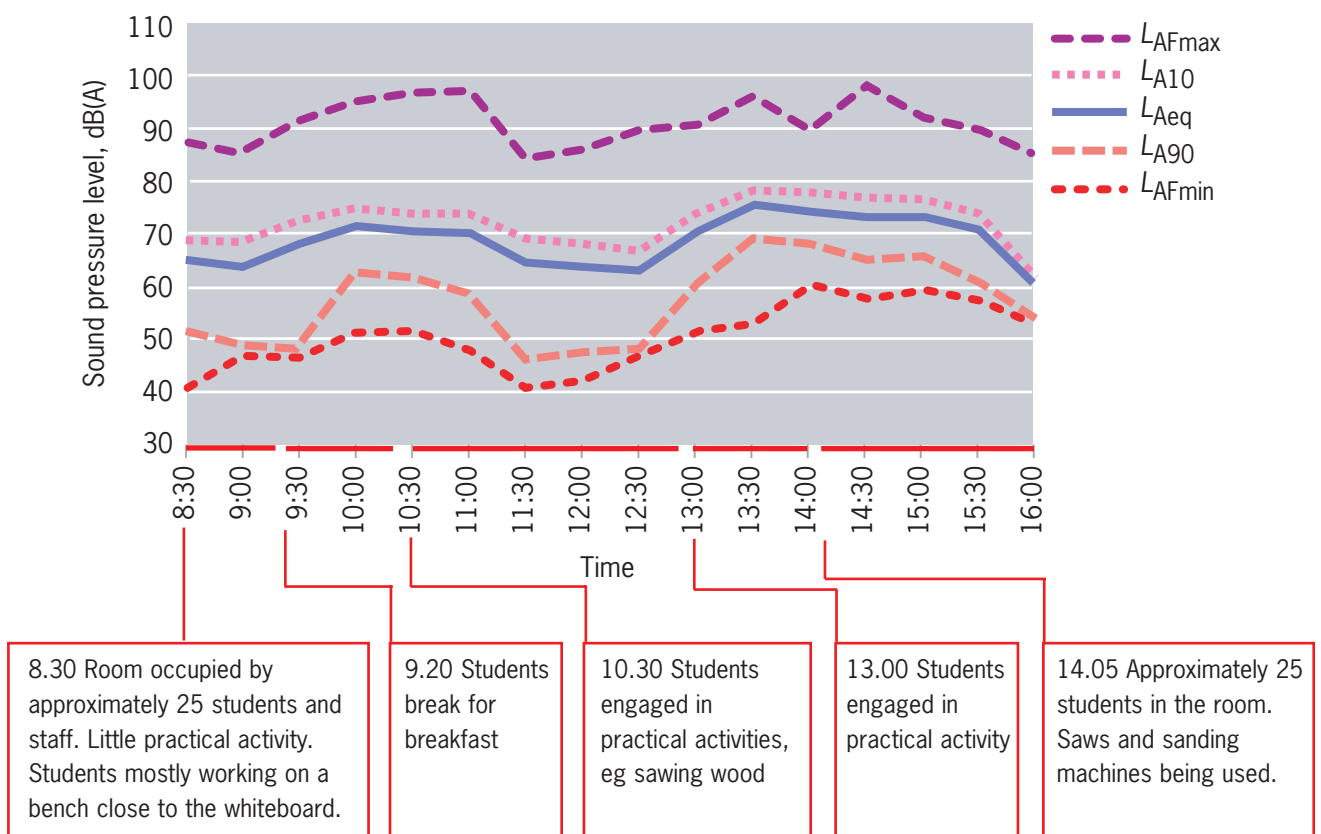
Figure 7.10.9: Workshop area sound pressure levels

areas. The levels in these areas are significantly higher than would be expected in classrooms due to the machinery noise. During the period of highest noise, 76 dB $L_{Aeq,30min}$, the signal to noise ratio would result in inadequate speech intelligibility for a teacher talking to a group of students.
